In-Service Oil Tank Cleaning and Inspection System: Results of Eight (8) Independent Validations

**Eugene B. Silverman
InTANK Services, Inc.**

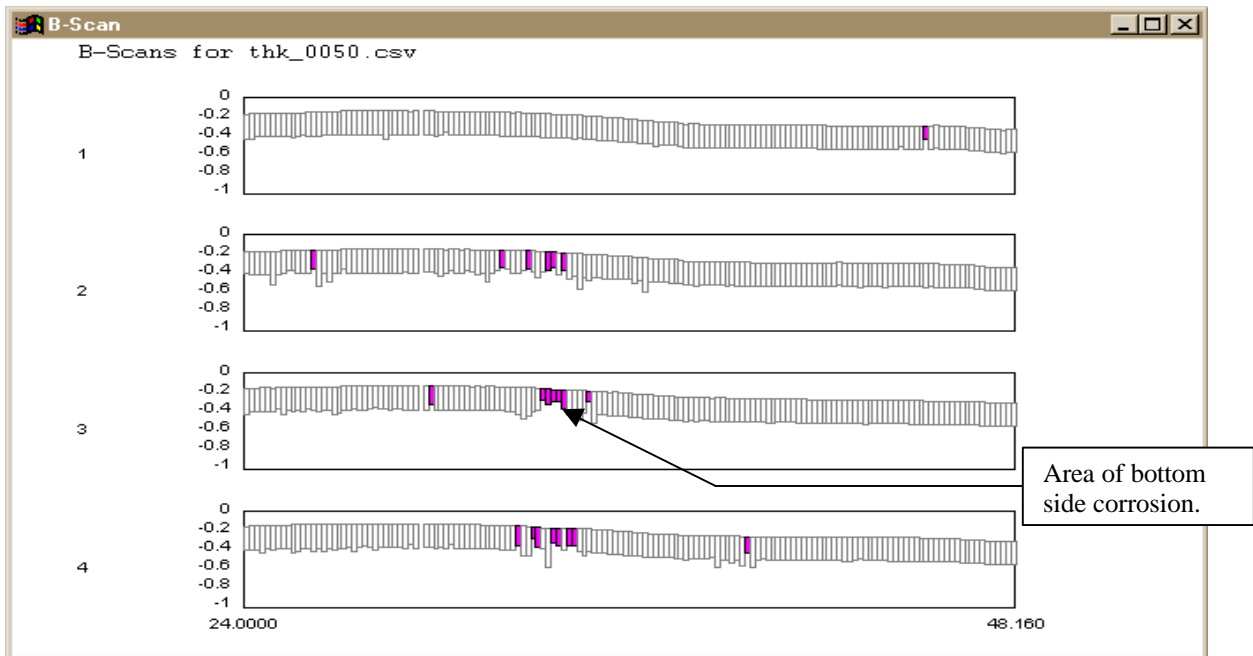
Figure 2. Example of a B-scan plot showing the ultrasonic thickness readings from four transducers. Primarily bottomsides pitting is shown.
