In-Service Oil Tank Cleaning and Inspection System: Results of Eight (8) Independent Validations

**Eugene B. Silverman
InTANK Services, Inc.**

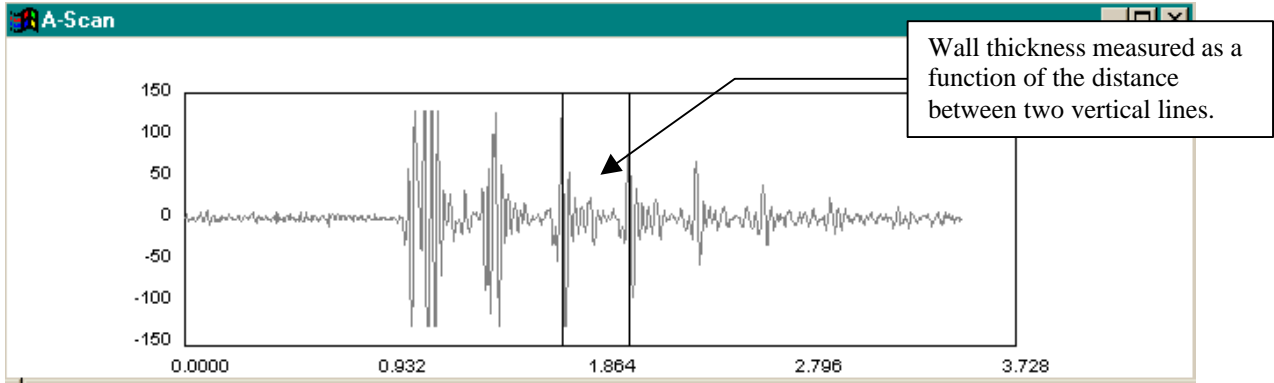
Figure 1. Example of an A scan plot showing the front and rear walls from which thickness measurements are derived.

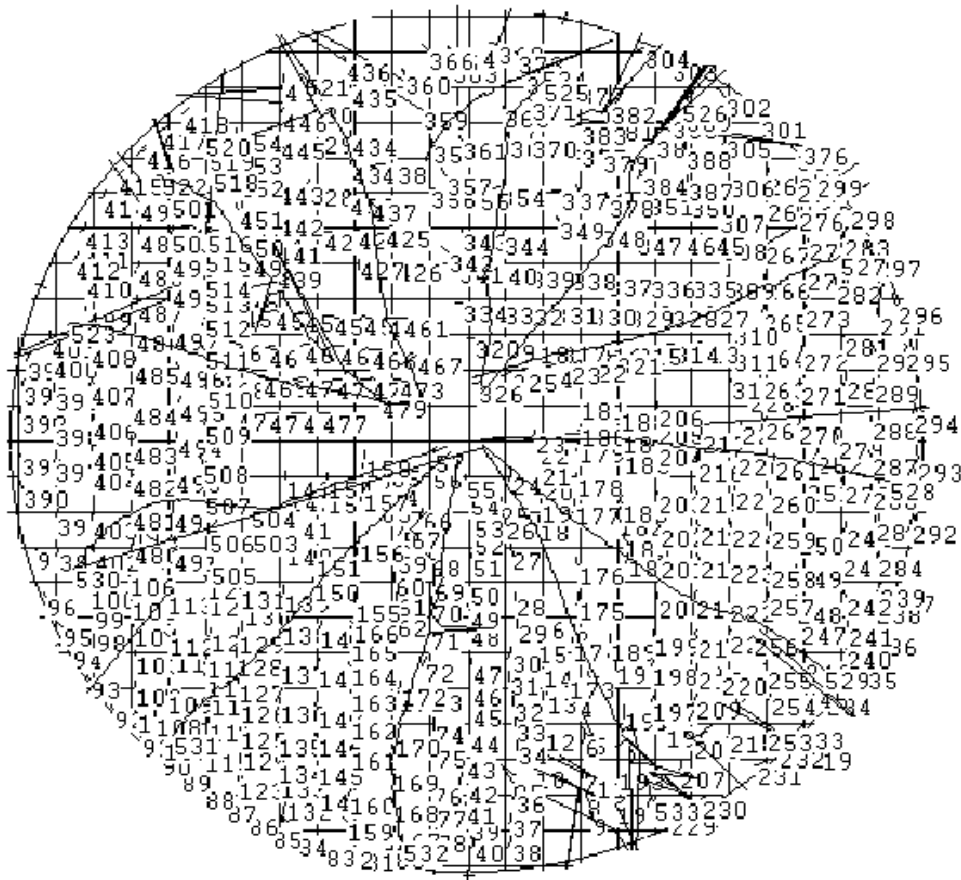
All UT data were correlated with the navigation position files and the actual location of all significantly corroded areas and thinning (below a pre-determined threshold) were identified for the out-of-service inspection. In all cases, certain indications were identified for further out-of-service analysis. Many locations were chosen for detailed analysis. Additionally, some tank shell settling was found in certain tanks. Figure 3 presents a plan view of a typical distribution of scans for an in-service floor inspection.

Figure 3. Plan view of a typical distribution of scans for an in-service floor inspection.
